Office of the Tyrolean State Government

Coordination and support of Wildlife warning systems in Tyrol

REPORT 2018

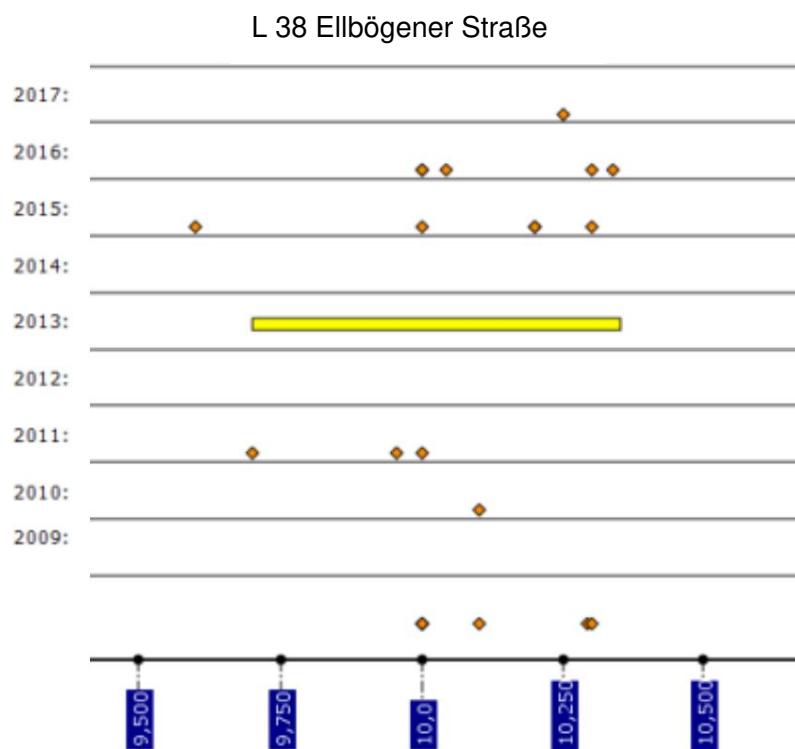
Figure 1: L 38 Ellbögener Straße; Yellow bar = optical and acoustic wildlife warning devices combined

The examples of L 38 Ellbögener Straße (Figure 1) and B 177 Seefelder Straße (Figure 2) clearly demonstrate that the wildlife warning systems installed in 2013 are insufficient to reduce the number of accidents involving wildlife. This can be due to various reasons, such as defective devices, the wrong choice of devices, or difficult terrain (e.g., steep embankments) in the surrounding area.

Routes like these need to be evaluated and optimized.

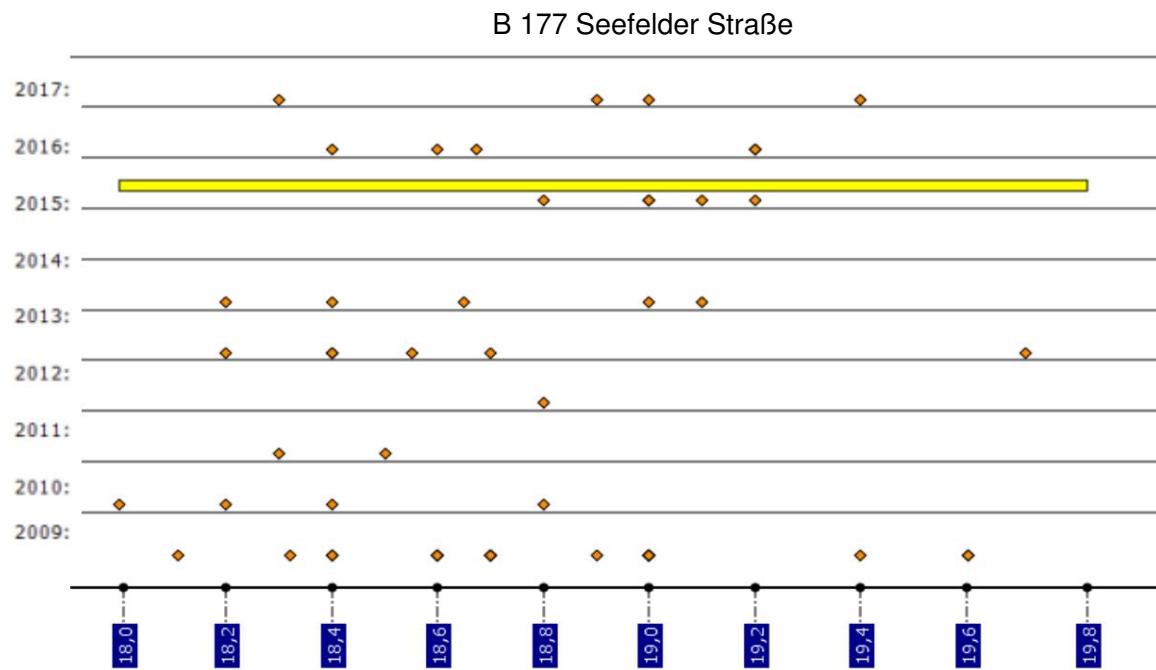
Figure 2: B 177 Seefelder Straße; Yellow bar = optical and acoustic wildlife warning devices combined

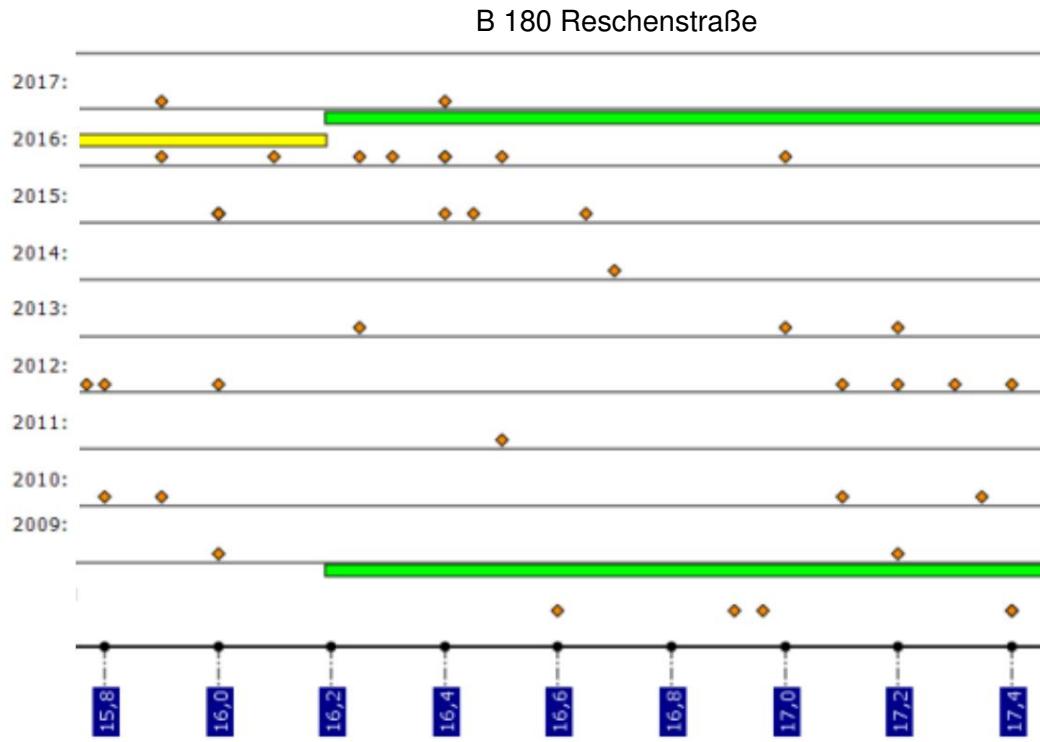
Figure 3: B 180 Reschenstraße; Yellow bar = optical and acoustic wildlife warning devices Combined; Green bar = reflectors

Along the B 180 Reschenstraße (Figure 4) the number of wildlife accidents between km 15.8 and 17.4 was significantly reduced by the use of reflectors and a combination of reflectors with acoustic wildlife warning devices.

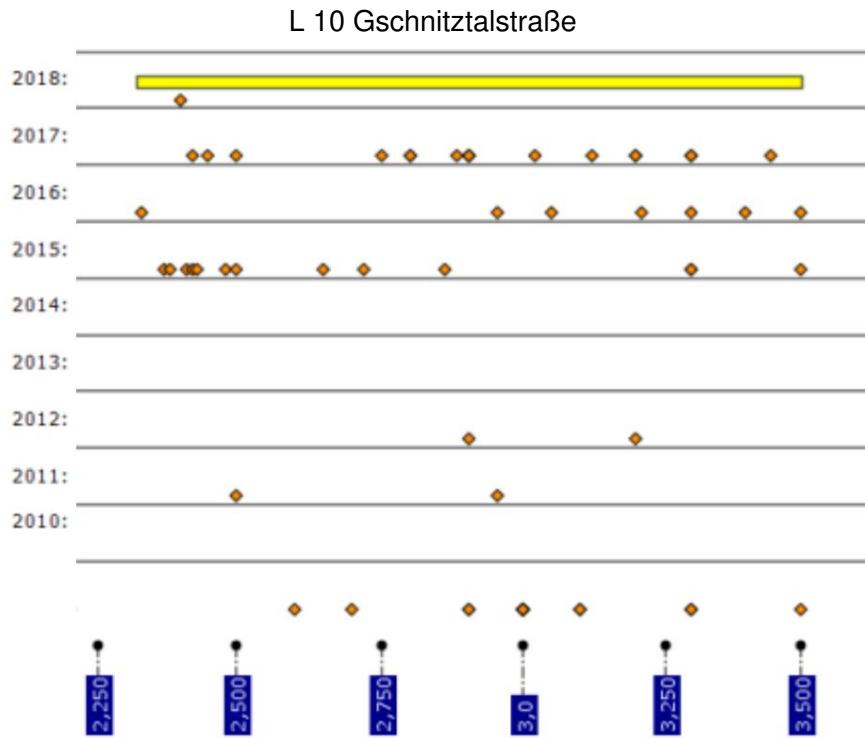
Figure 4: L 10 Gschnitztalstraße; Yellow bar = optical and acoustic wildlife warning devices combined

Figure 4 shows that a section of the L 10 Gschnitztalstraße, which has seen numerous wildlife collisions in recent years, was equipped with a combination of reflectors and acoustic wildlife warning devices in 2018. An evaluation of the effectiveness will be carried out as soon as data on roadkill is available.

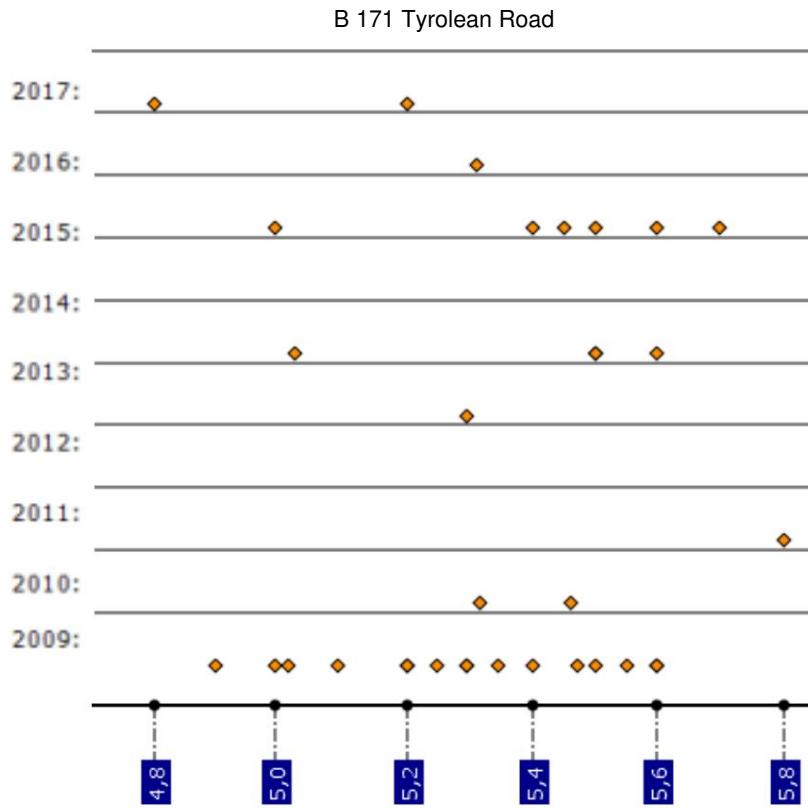
Figure 5: B 171 Tiroler Straße – section of road which has been closed due to an increased number of wildlife collisions should be equipped

The following two images (5 and 6) show road sections with a high incidence of wildlife collisions. Action is needed here. These sections will be included in the project and equipped accordingly.

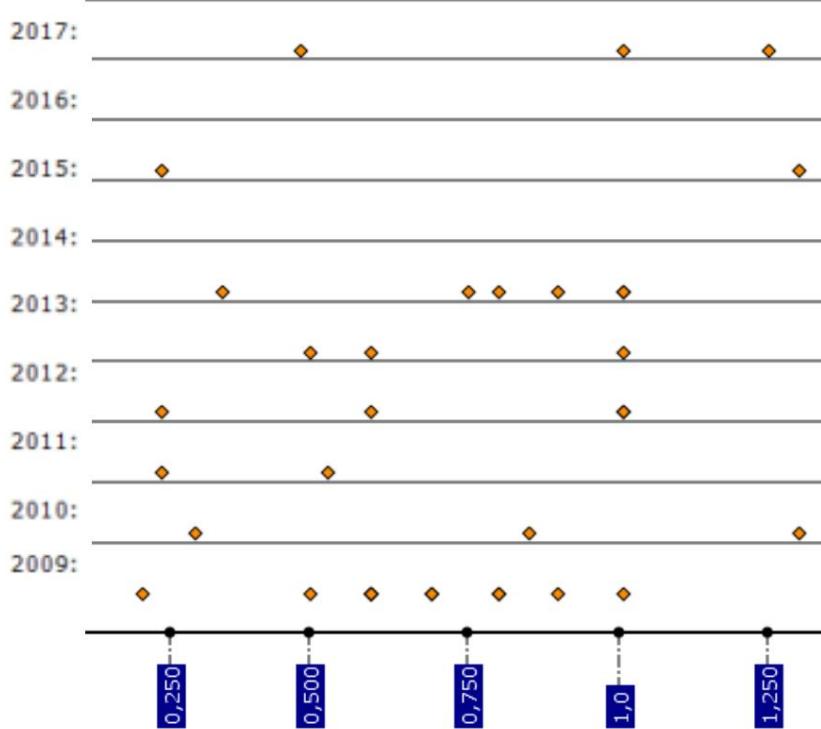
Figure 6: L 208 Bad Häring-Schwoicher Straße – road section which is due to
It should be equipped to withstand increased wildlife collisions.
